# Manhole Inspection Summary

Manhole # S43A2\_030MH

Insp Date: **12/19/07 11:20 AM**

**Location** Address: **1201 Cambria St**

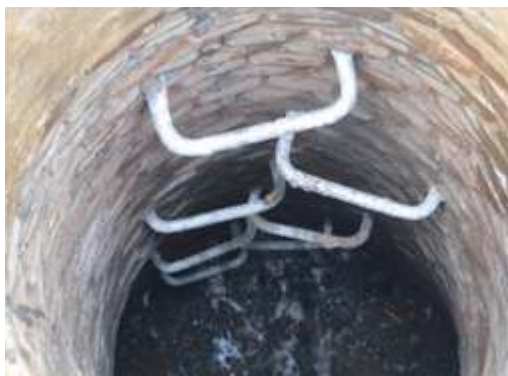
Steps

Count: **7** Missing: **0** ☐ Corroded

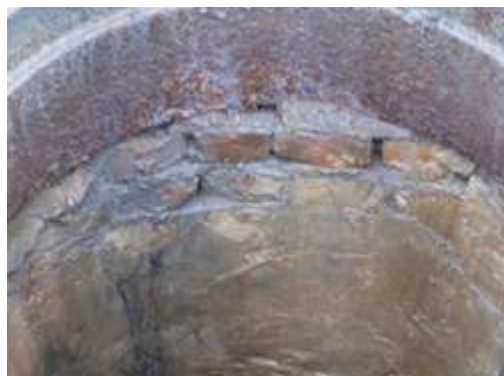
Defect 1

Condition: ☐ Sound ☐ Cracked ☐ Root Intrusion ☒ **Loose Brick** ☐ Deteriorated

Infiltration: ☐ None ☐ Joint ☐ Cracks ☒ **Mortar** ☐ Roots ☐ Wall

Infiltration

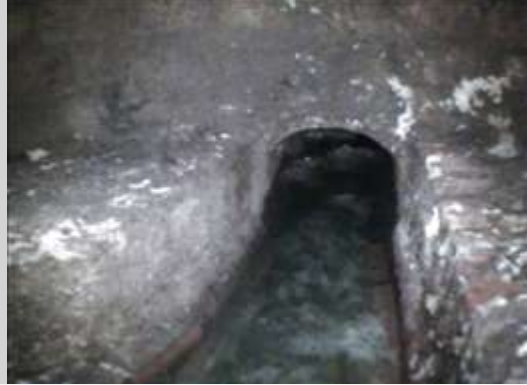
12 O'Clock Outflow

10 in. Circular Service Sewer  
Pipe Out @ 12 O'Clock

Pipe Height: **10.8** (in.) Rod and Bar (Angled)  
Pipe Material: **Clay** ☐ Pipe Lined  
Invert Depth: **14.33** (ft.) Flow Characteristics: **Slow**  
Deposits: ☒ None ☐ Mud ☐ Sludge ☐ Debris ☐ Grease  
Silt Depth: (in.) Deposits Extent:  
Infiltration: **None** Pipe Seal Cond: **Sound**

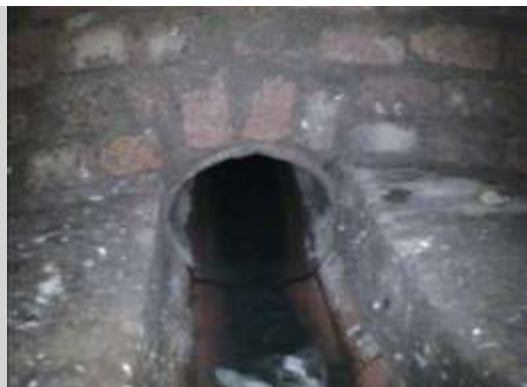
6 O'Clock Inflow

10 in. Circular Service Sewer  
Pipe In @ 6 O'Clock

Pipe Height: **9.6** (in.) Rod and Bar (Angled)  
Pipe Material: **Clay** ☐ Pipe Lined  
Invert Depth: **14.21** (ft.) Flow Characteristics: **Slow**  
Deposits: ☒ None ☐ Mud ☐ Sludge ☐ Debris ☐ Grease  
Silt Depth: (in.) Deposits Extent:  
Infiltration: **None** Pipe Seal Cond: **Sound**

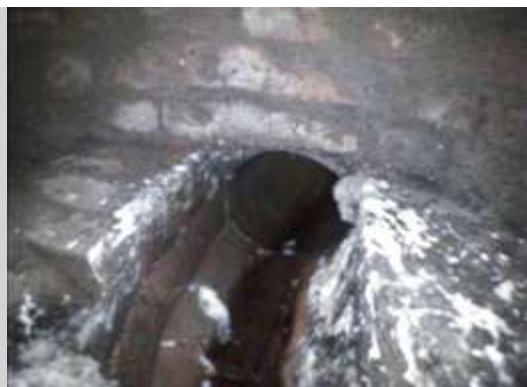
9 O'Clock Inflow

6 in. Circular Service Sewer  
Pipe In @ 9 O'Clock

Infiltration: **None**

Pipe Seal Cond: **Sound**
